POST-STRIKE ANALYSIS
LAM THAO SUPERPHOSPHATE PLANT
NORTH VIETNAM

CIA/PIR 65061

DATE Dec. 1965

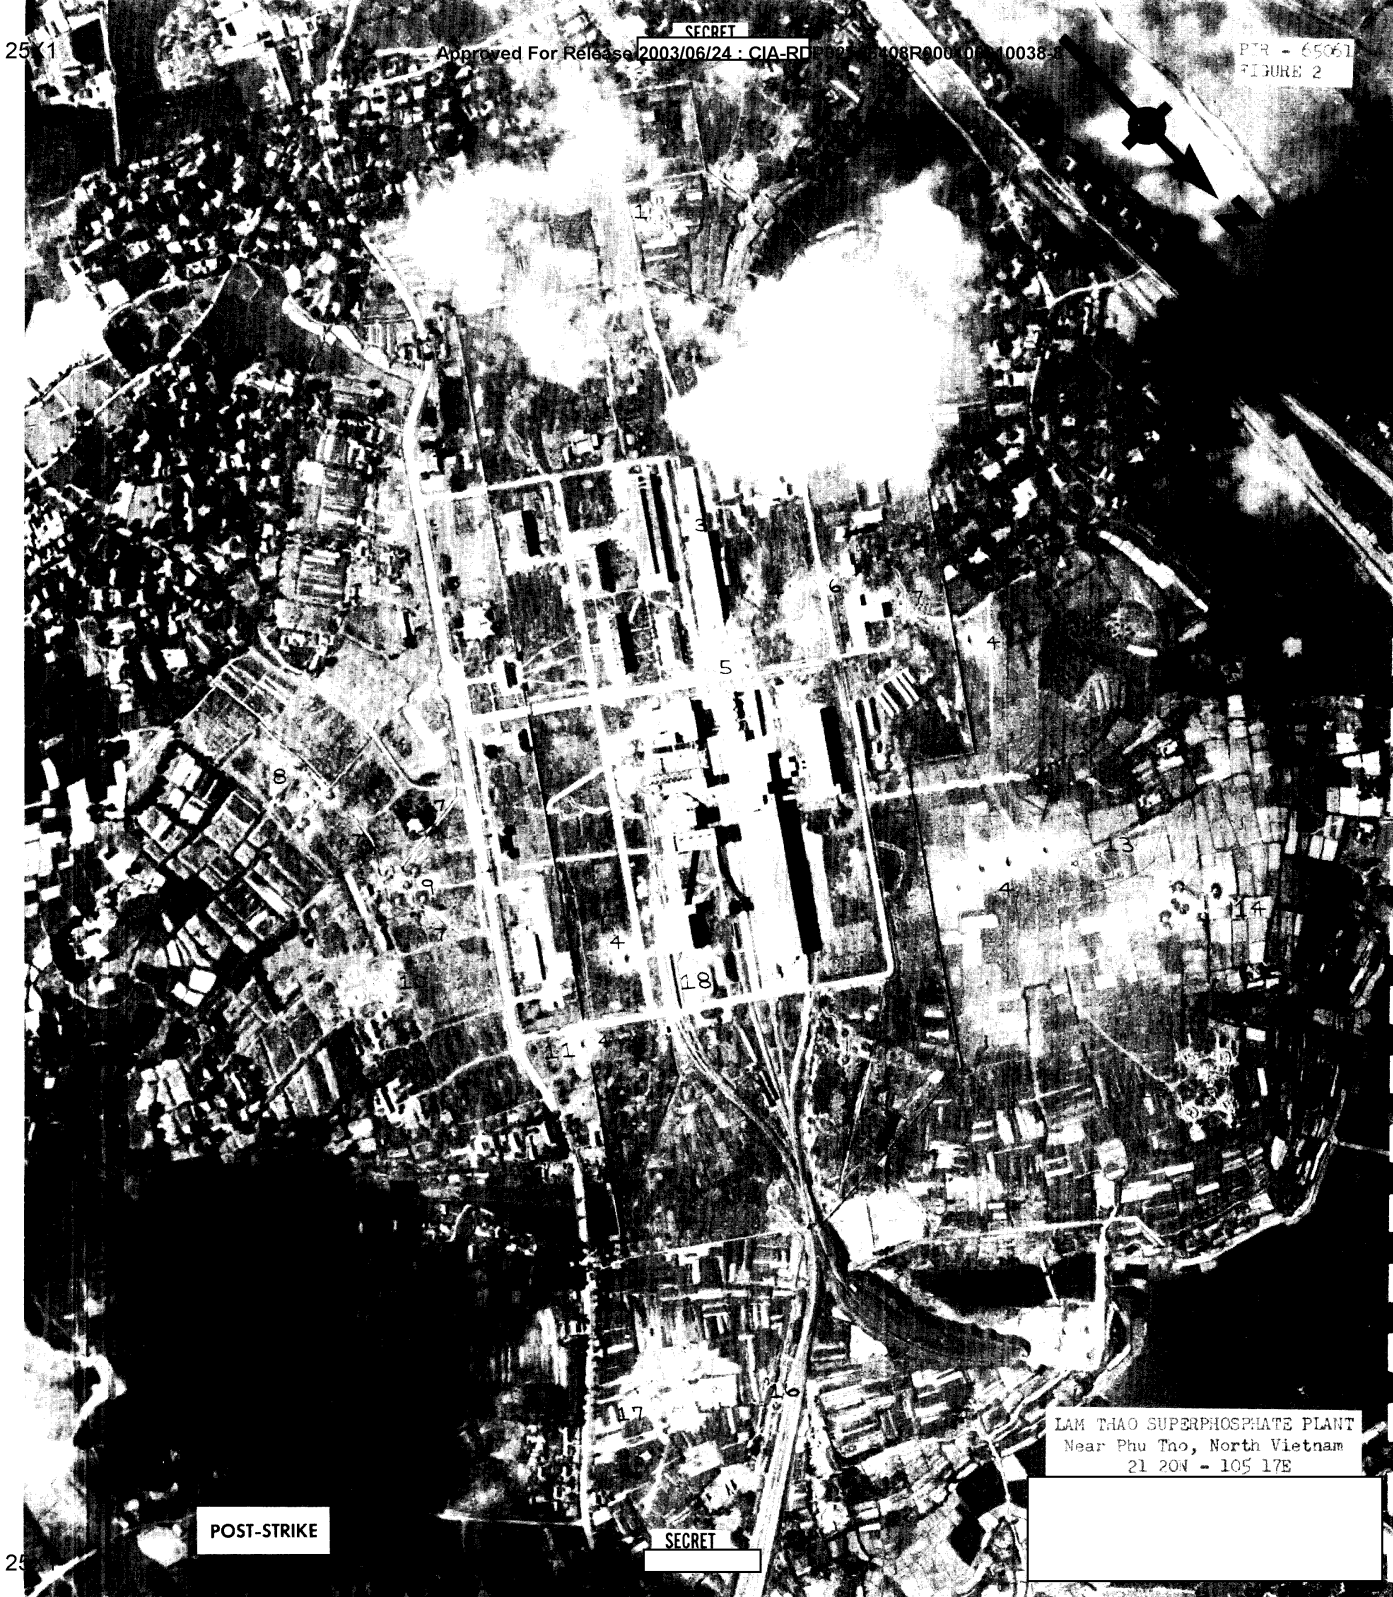
PTR - 65061
FIGURE 2

A more detailed discussion of the bomb damage and construction activity/changes follows; the numbers below correspond to the numbers on Figure 2.

- (1) Four gun AW position, unoccupied
- (2) Two gun AW position, unoccupied
- (3) New section of warehouse-production building under construction
- (4) Bomb crater(s)

- (5) North end of the warehouse-production building destroyed; portions of the rail lines on either side of this building appear damaged
- (6) Portion of security fence destroyed

- (7) Personnel/communication trenches, constructed since [REDACTED]
- (8) Four gun light AAA position, occupied
- (9) Four gun light AAA position, unoccupied

- (10) Four gun light AAA position, unoccupied
- (11) Support building adjoining plant area destroyed by bomb
- (12) Three gun AW position, unoccupied
- (13) Four gun AW position, unoccupied

- (14) Four gun light AAA position, occupied
- (15) Four gun light AAA position, occupied
- (16) Two gun AW position, unoccupied
- (17) Four gun light AAA position, occupied

- (18) Slight change in configuration of materiel stored in open

POST-STRIKE

There are a number of bomb craters in and near the plant, but bomb damage was rather moderate. Buildings essential to production such as the sulfuric acid plant, ore crushing and processing buildings, boilerhouse, and superphosphate production building appear to be undamaged. A warehouse-production building was partially destroyed and the rail lines serving this building appear to be damaged. In addition, a small support building adjoining the plant area was destroyed. Presumably, the damage to the warehouse-production building and the rail lines will slow down, but not stop production.

NOTE: With the exception of Annotation 9, all of the AAA and AW positions have been constructed during the period [REDACTED]
